Manhole Inspection Summary

Manhole # S23K__045MH

Insp Date: **6/11/08 3:16 PM**

Location Address: **241 McHenry St**

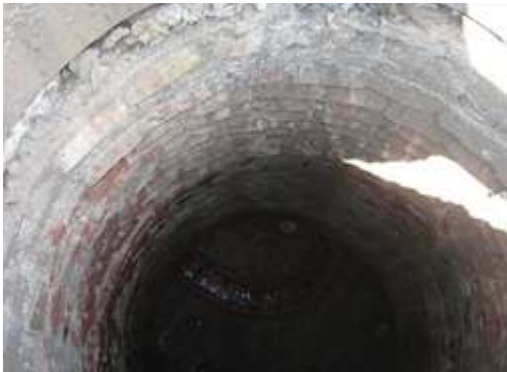
Defect 2

Frame Offset: **1.** (in.) Condition: ☐ Sound ☐ Cracked ☒ **Leaks**
75

frame-lid infiltration

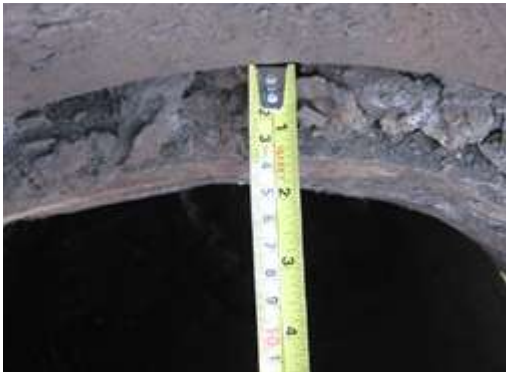
Defect 3

1.75 Frame offset

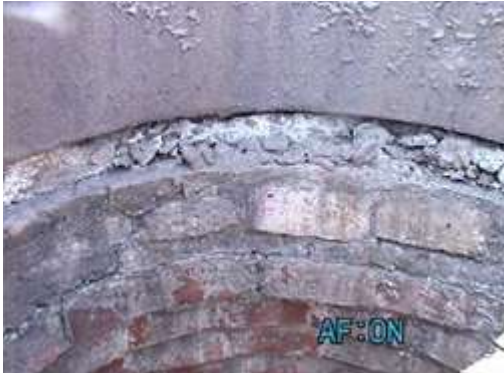
Defect 1

Condition: ☐ Sound ☐ Cracked ☐ Root Intrusion ☐ Loose Brick ☒ **Deteriorated**

Infiltration: ☐ None ☒ **Joint** ☐ Cracks ☒ **Mortar** ☐ Roots ☐ Wall

chimney deteriorated, signs of infiltration at joint/mortar

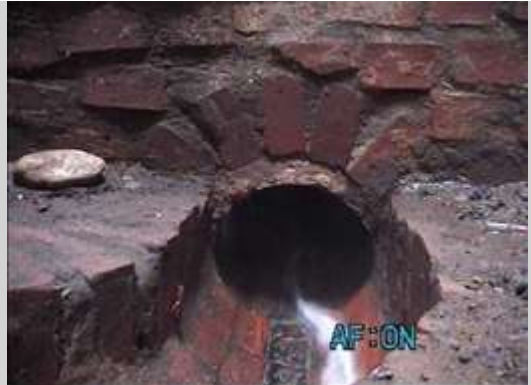
12 O'Clock Outflow

Pipe Height: **8.4** (in.) Rod and Bar (Angled)
Pipe Material: **Clay** ☐ Pipe Lined
Invert Depth: **9.73** (ft.) Flow Characteristics: **Slow**
Deposits: ☒ None ☐ Mud ☐ Sludge ☐ Debris ☐ Grease
Silt Depth: **0** (in.) Deposits Extent:
Infiltration: **None** Pipe Seal Cond: **Sound**

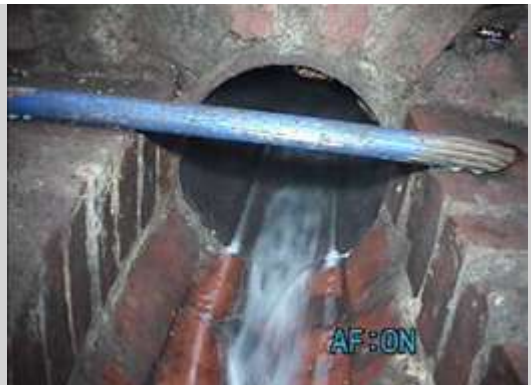
9 O'Clock Inflow

Pipe Height: **8.4** (in.) Rod and Bar (Angled)
Pipe Material: **Clay** ☐ Pipe Lined
Invert Depth: **9.21** (ft.) Flow Characteristics: **Slow**
Deposits: ☒ None ☐ Mud ☐ Sludge ☐ Debris ☐ Grease
Silt Depth: **0** (in.) Deposits Extent:
Infiltration: **None** Pipe Seal Cond: **Sound**
